The Location and Structure

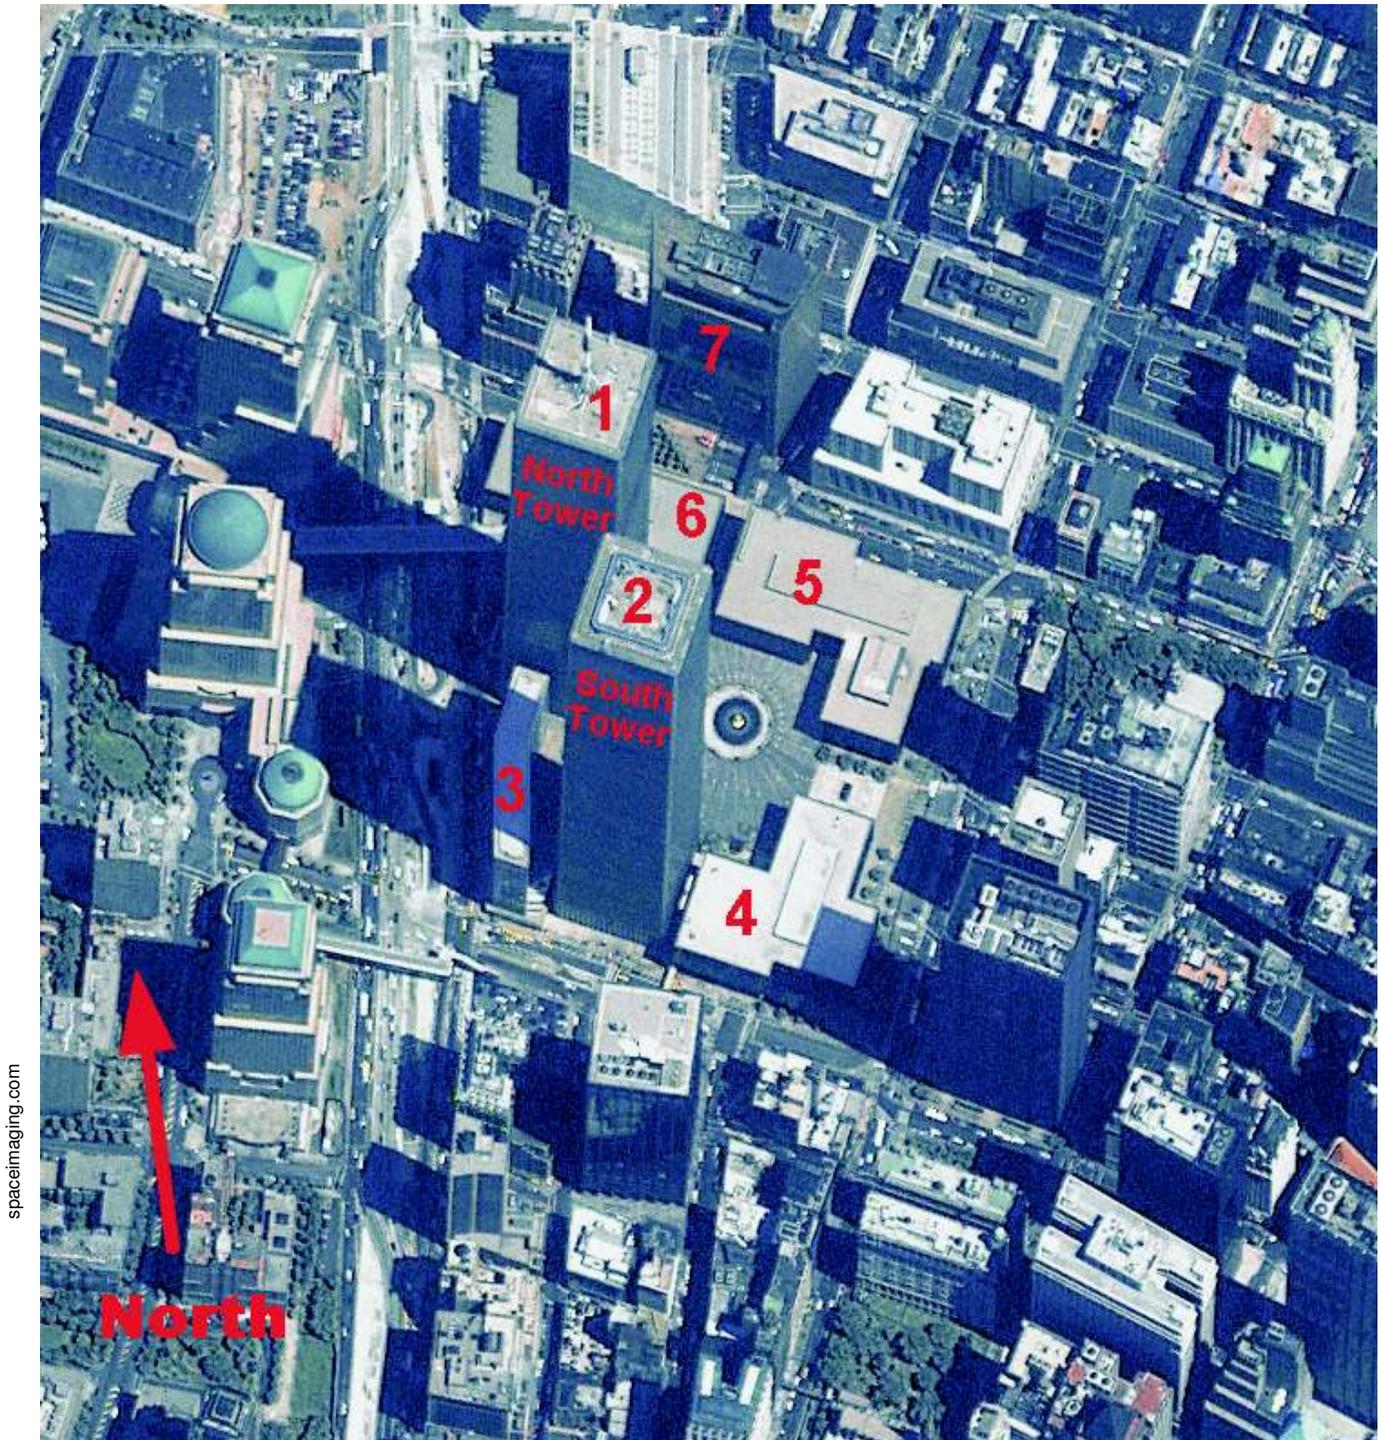
Figure 3-1 The World Trade Center from satellite, as of June 30, 2000

Figure 3-1 is a section of a photo taken on June 30, 2000 by the IKONOS satellite. The towers were identical in appearance except for one feature, namely, there was a

large antenna on top of the North Tower. The South Tower had an observation deck instead. Therefore, look for the antenna when you are wondering which tower is which.

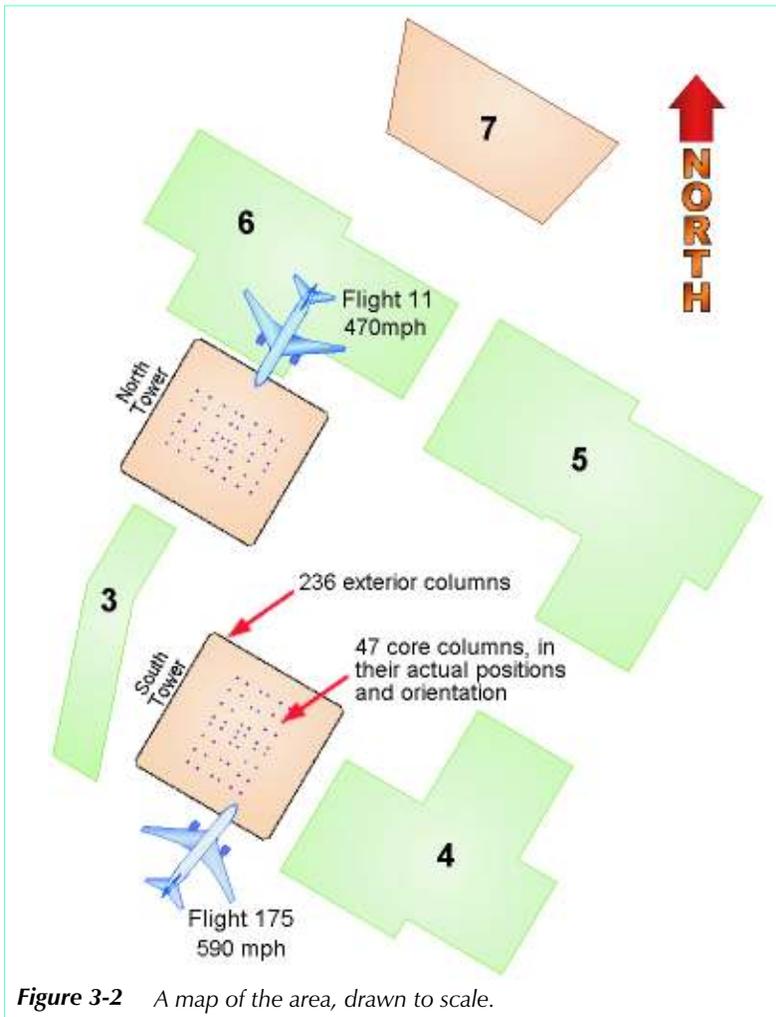
Figure 3-2 A map of the area, drawn to scale.

At the center of the towers were 47 steel columns laid out in a slightly irregular, rectangular grid. These are often referred to as “core” columns. Figure 3-2 shows the location and orientation of these core columns, and the position of the airplanes when they hit the towers. The airplanes are the correct size in relation to the buildings, so if the airplanes seem small it is because the towers were so large. The entire airplane could fit inside a tower if the floors were tall enough and if there were no core columns or elevator shafts in the way.

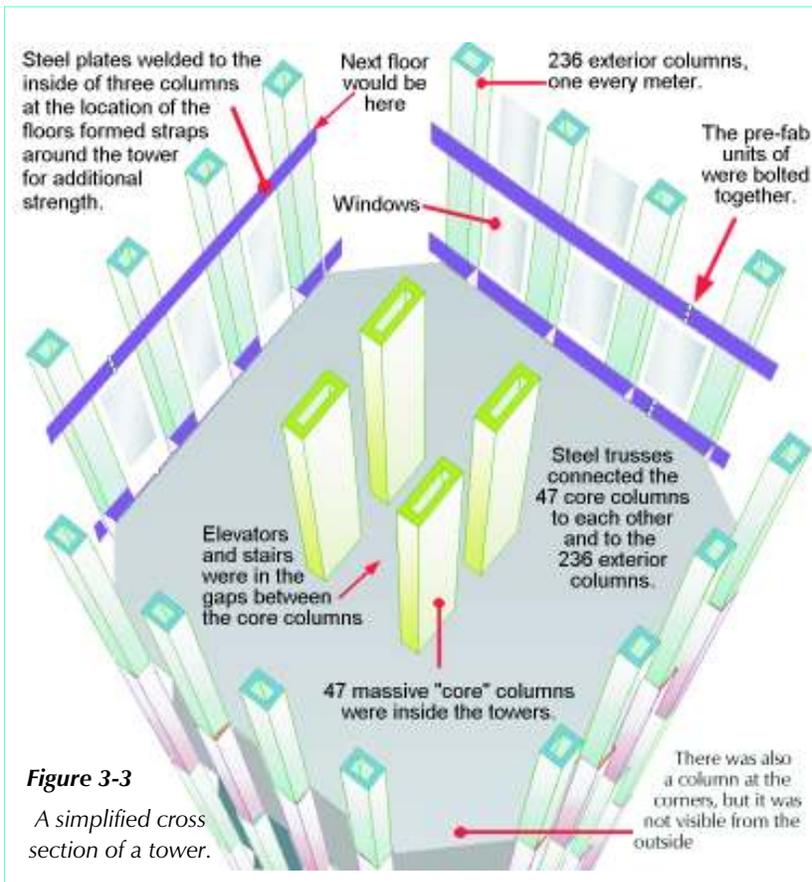
Figure 3-3 A simplified cross section of a tower.

Figure 3-3 is a simplified diagram to show the arrangement of the exterior and core columns. Along the outside of the towers were steel columns every meter. There was a total of 236 of these exterior columns, although this diagram shows only 16. These columns were literally on the exterior of the tower. There was also a column at each of the four corners, making a total of 240 columns, but those four columns were inside the tower.

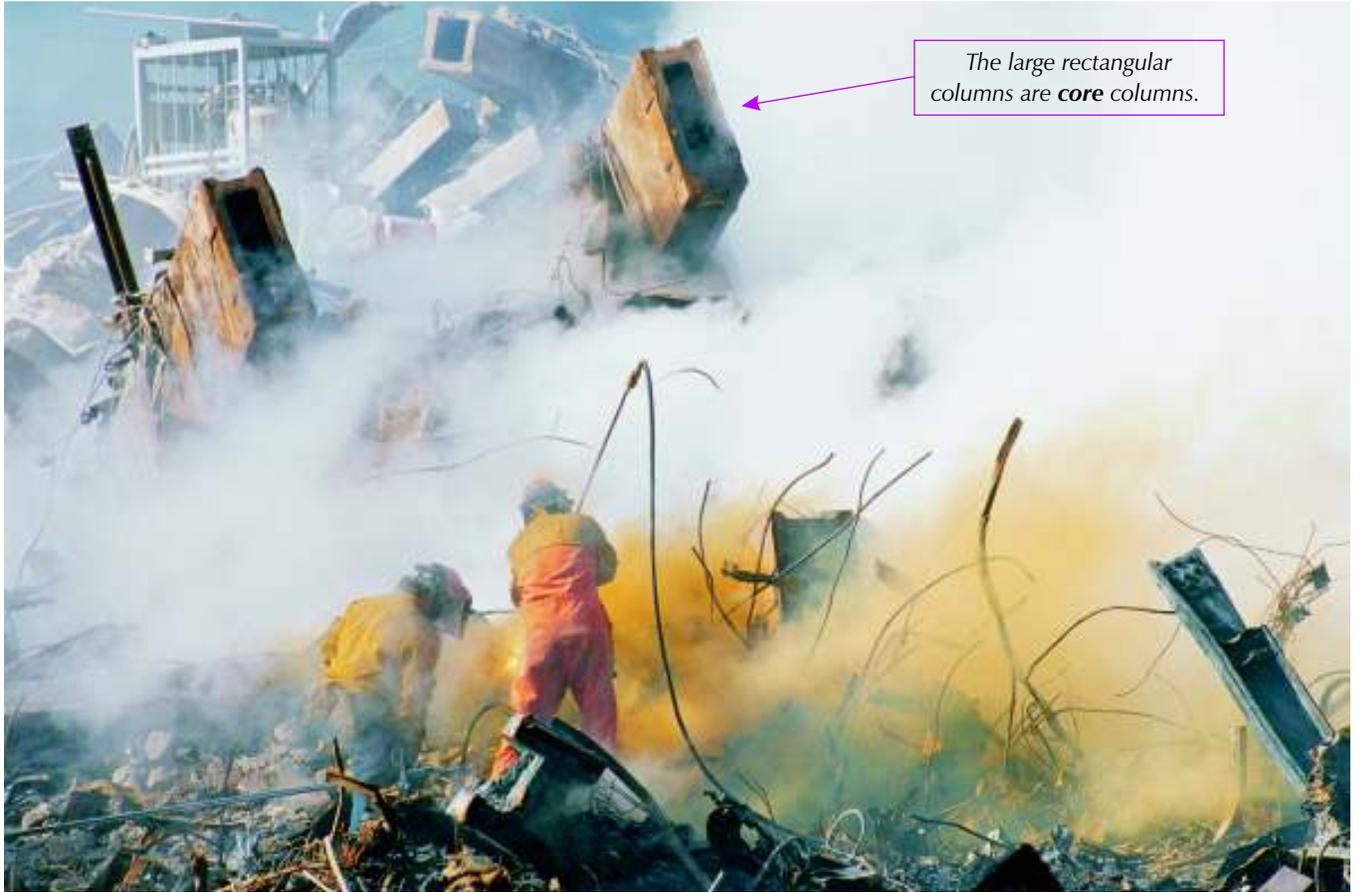
The large rectangular columns are **core** columns.

Figure 3-4 The workers are cutting the steel with giant torches.

Figures 3-4 and 3-5 show some of the thicker core columns. Both photos can also make you wonder how the workers could claim they were looking for survivors. Nobody could be alive in those smoking piles of hot rubble.

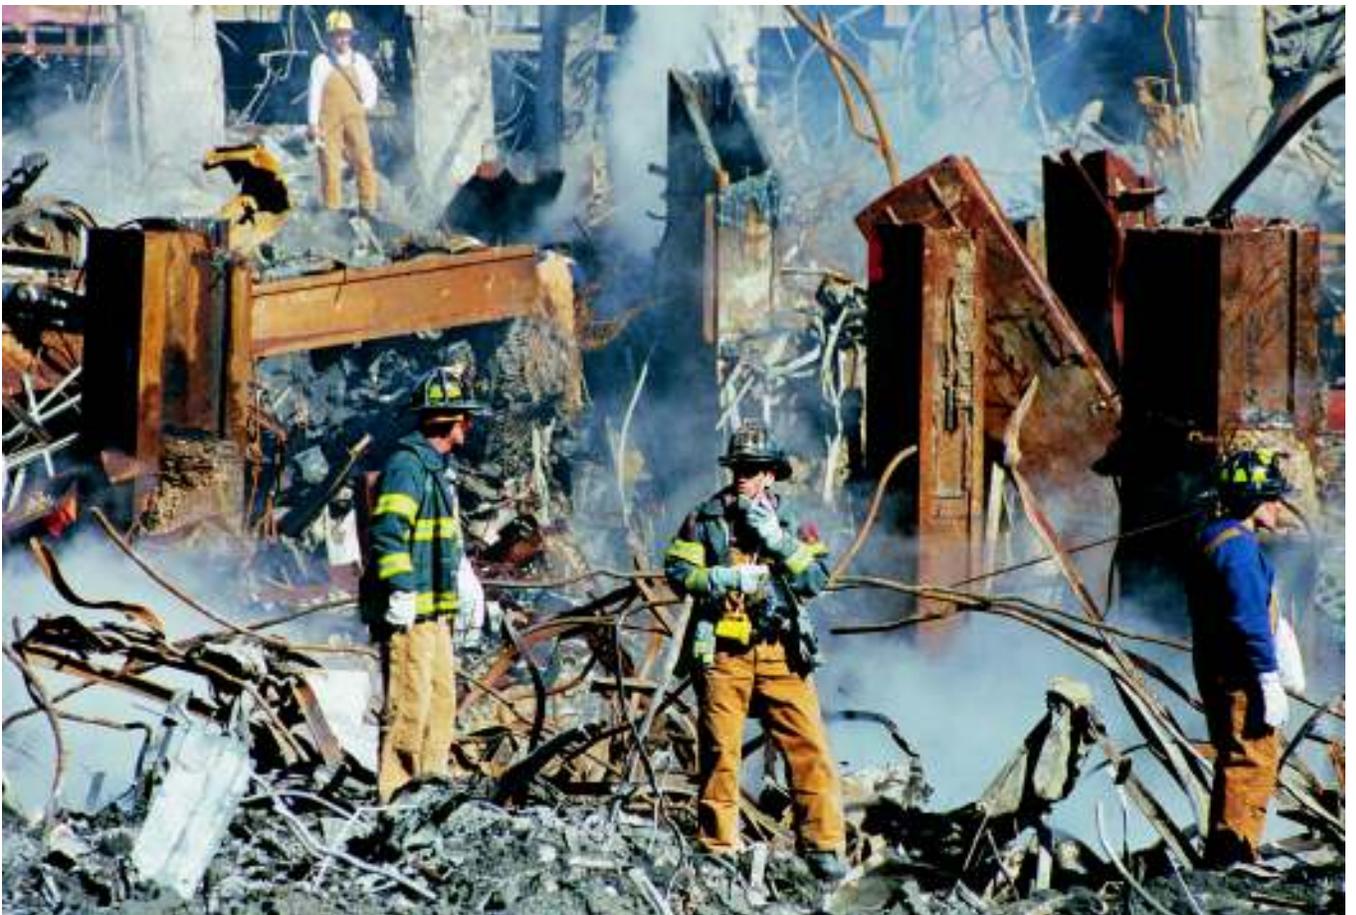
Figure 3-5 The core column in the center appears cut by a torch. The workers cut the steel so quickly that it is difficult to determine which damage was from them.

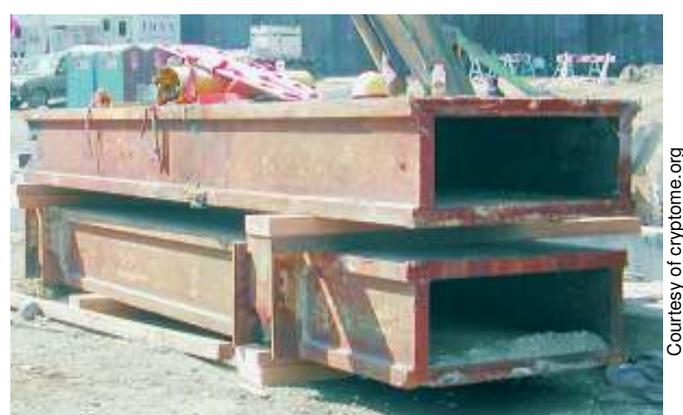
Figure 3-6 Core columns, sliced and ready to sell as scrap. This photo was taken at the WTC on October 3rd, 2001.

Figure 3-6 shows a core column, sliced into pieces and ready to sell as scrap metal. As is typical of photos of the rubble, there is no sign that the core columns buckled or bent. Rather, most columns appear to have broken at their joints. The columns were obviously very strong, but the joints appear to have been weak.

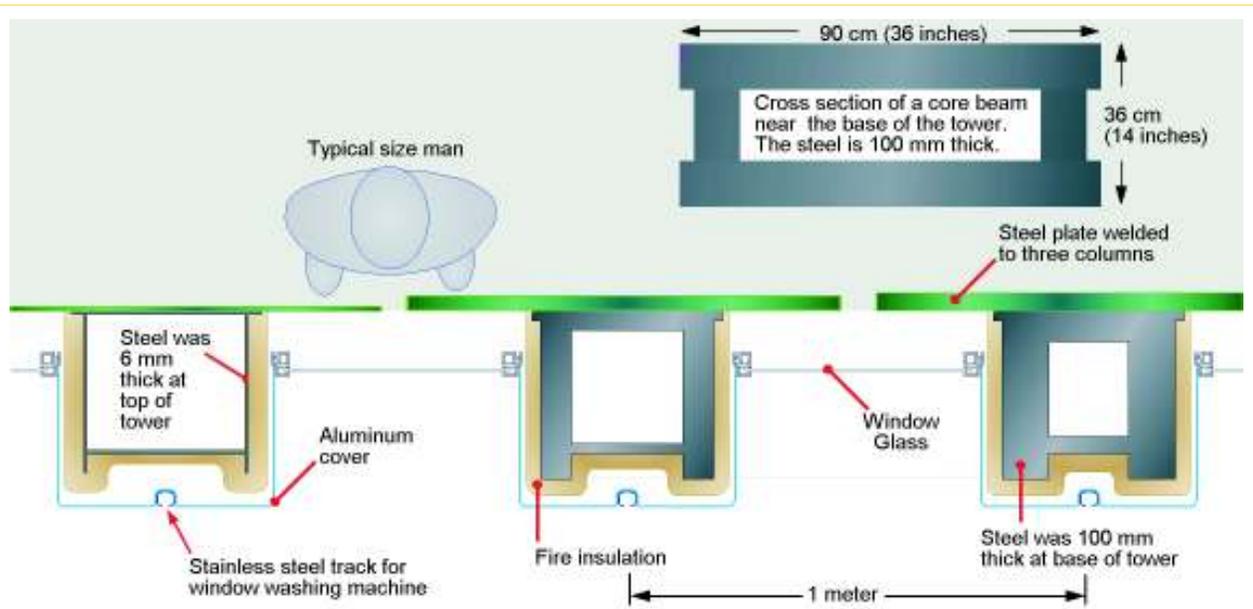
Figure 3-7 Cross section of exterior columns. The steel in each of these three columns is a different thickness to show how the columns varied from the bottom to the top of the tower. The thinnest column would be at the very top of the tower, and thickest would be at the ground. A cross section of the most massive core column is shows for a size comparison. A core column that thick would be at the bottom.

Figure 3-7 shows a cross-section of three of the exterior columns. Each column is a different thickness to show how the thickness varied from the bottom of the tower to the top. The steel was as thick as 100mm in the columns near the ground, but only 6mm at the top. A cross-section of one the most massive core columns is included in this figure to show its size and shape compared to the exterior columns. A core column with 100mm walls would be near the bottom of the tower.

Note that a fire inside the building would be in direct contact with only one of the four walls of these exterior columns; three walls were surrounded by the outside air. This made it difficult for a fire to raise the temperature of the exterior columns by a significant amount.

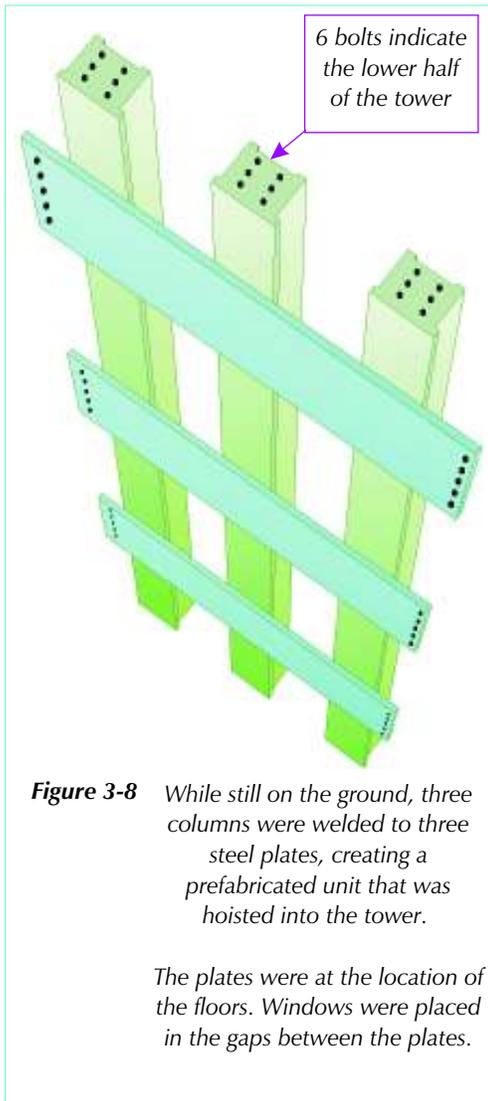
Figure 3-8 While still on the ground, three columns were welded to three steel plates, creating a prefabricated unit that was hoisted into the tower.

The plates were at the location of the floors. Windows were placed in the gaps between the plates.

Three steel plates were welded to three columns while they were on the ground, creating a prefabricated unit (Figure 3-8). The units were hoisted into the tower and bolted together in a staggered manner (Figure 3-9). Supplemental welds were added to units near the bottom of the tower for additional strength. These plates formed straps around the tower.

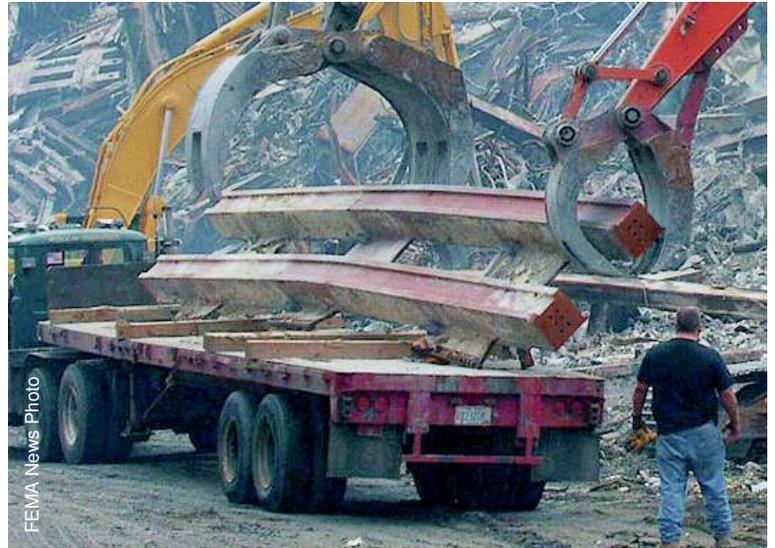
Figure 3-10 Two columns still attached to the three plates that made a pre-fab unit.

The six bolt holes at the ends of the columns indicate that these were in the lower half of the tower. The units in the upper section had only four bolt holes.

Figure 3-10 shows two exterior columns that are still attached to the steel plates that formed straps around the tower. The thickness of the steel and the six bolt holes at the bottom of each column indicate that these were somewhere in the bottom half of the tower. Columns higher up in the tower were made of thinner steel and had only four bolt

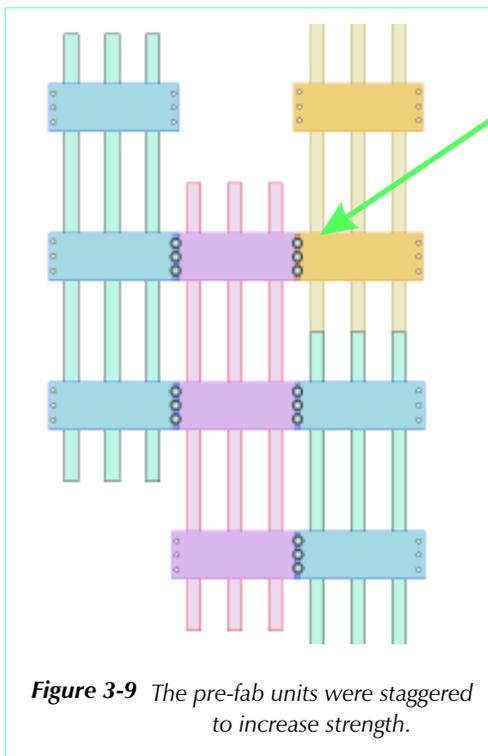
Figure 3-9 The pre-fab units were staggered to increase strength.

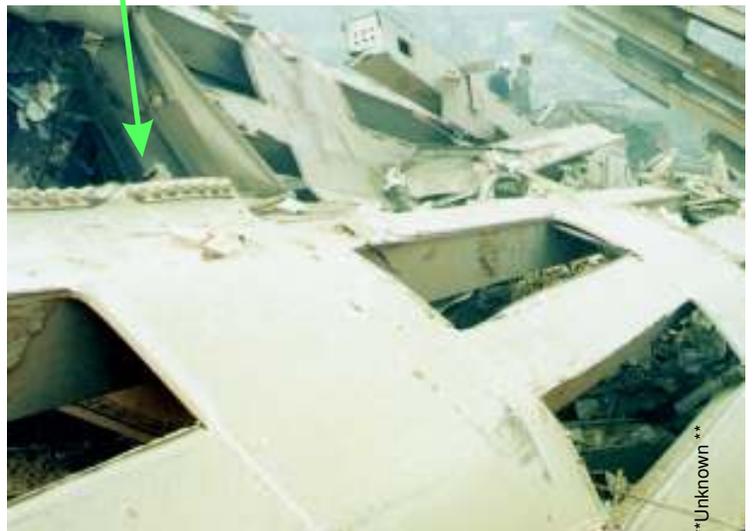
Bolts held the pre-fab units together

Figure 3-11 The bolts holding the pre-fab units together.

holes on each column. Figure 3-11 shows the bolts that held the prefab units together.

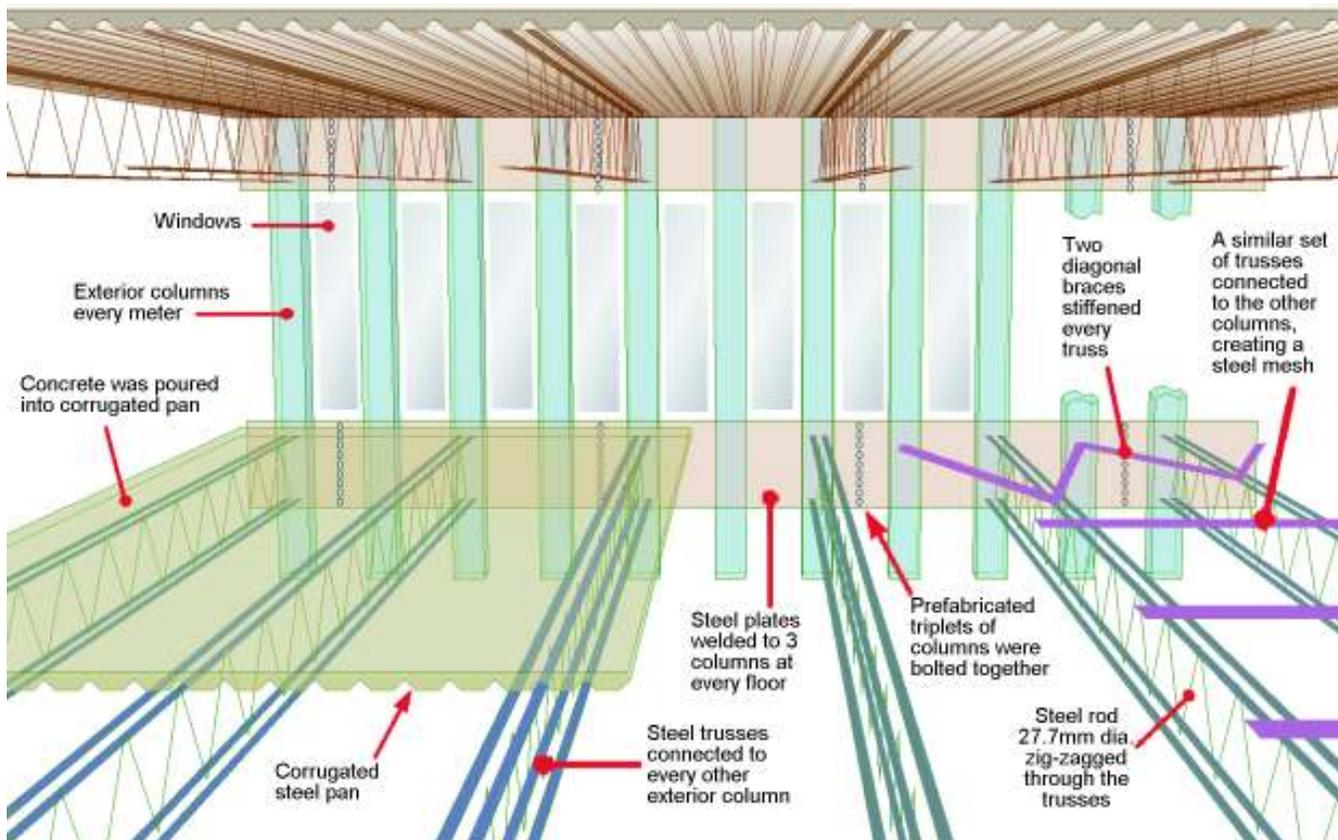
Figure 3-12 This is a view of the flooring between the core and exterior columns. The view is from the core columns towards exterior columns.

There were 56 exterior columns along each side of the tower. A truss connected to half of them, and diagonal braces connected the trusses to the other half. The trusses also connected to the 47 core columns. A similar set of trusses connected to the vertical steel columns created a steel mesh.

Concrete is used as a structural material in some bridges and buildings, but in the World Trade Center towers it was only a *flooring material*. The concrete was *not* holding the building together. Rather, the building was a 3-dimensional network of steel. Figure 3-12 is a view of two of the floors. The view is towards the windows, from a location near the core beams.

This diagram does not show all of the steel beams in the flooring. There was a similar set of trusses that ran perpendicular to the beams shown and connected to the columns on the other side of the tower. (The three purple lines along the right edge of the diagram show the direction and location of these criss-crossing trusses.) There were also

diagonal braces at the ends of every truss to further stiffen them (two sets of these braces are shown as purple lines.)
